COMMUNITY OVERVIEW AND SCRUTINY PANEL

PLAY AREAS

Report reference: CS 07/10

Summary: The report describes the current arrangements for management of the City Council's stock of equipped children's play areas and the issues this raises for standards of service delivery.

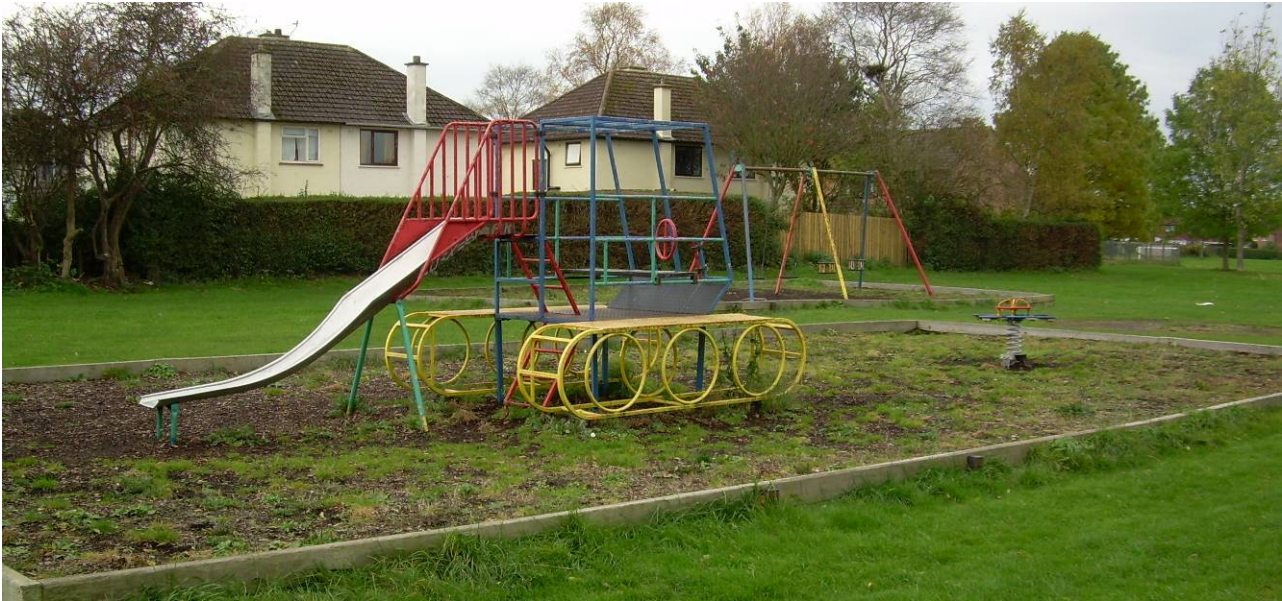
1. Parkside

Richter X-scales, installed Feb '91, half removed October 1997 as unsafe, totally removed November 1997

Seesaw removed early 2001

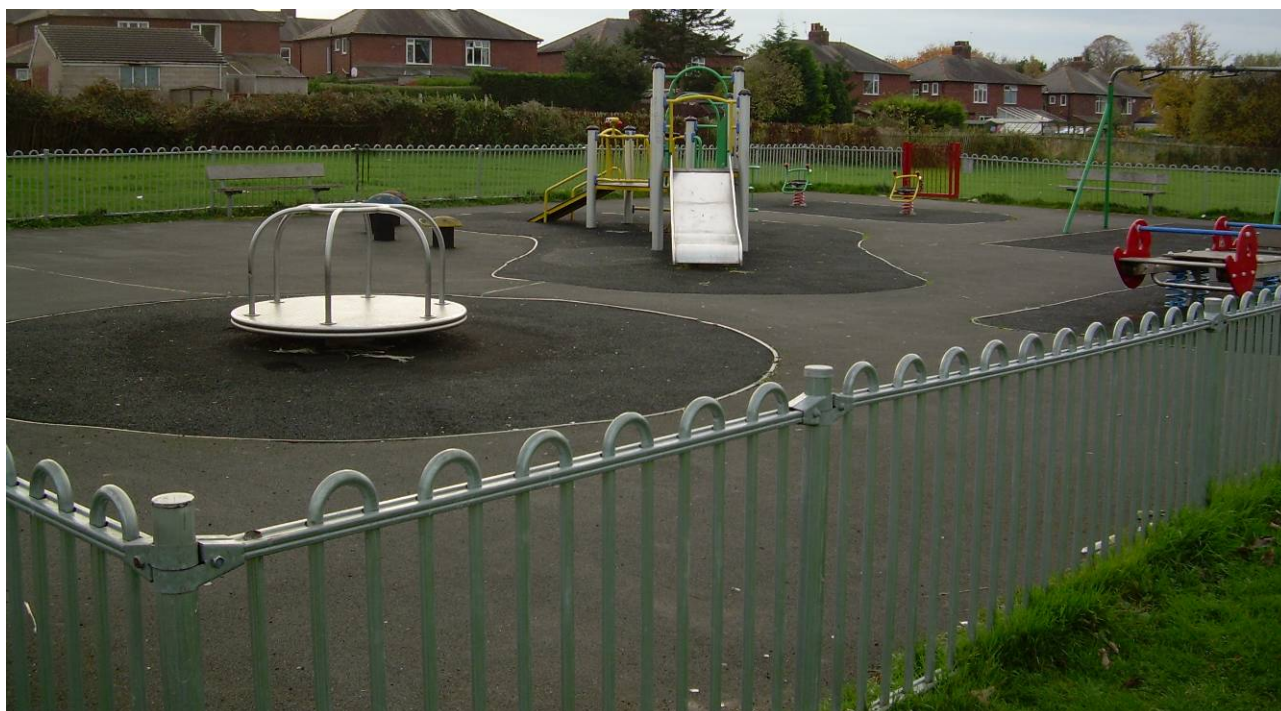
2. Clarksfield

?June/July 1994 Chestnut paling fence erected at top, along hedge line behind back alley for houses in Scotland Road to alleviate yob problems. Causes trouble in Rosebery Road by entrance to Etterby Lea Park allotments.

Always a lot of broken glass from bottles.

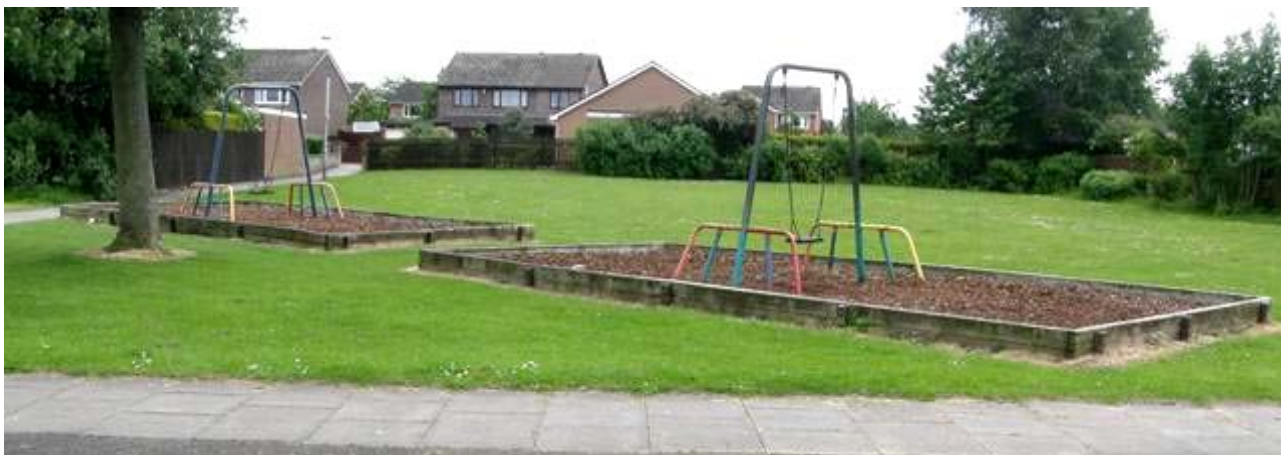
4. Kershope Road.

Tarmac pads from old equipment need removing.

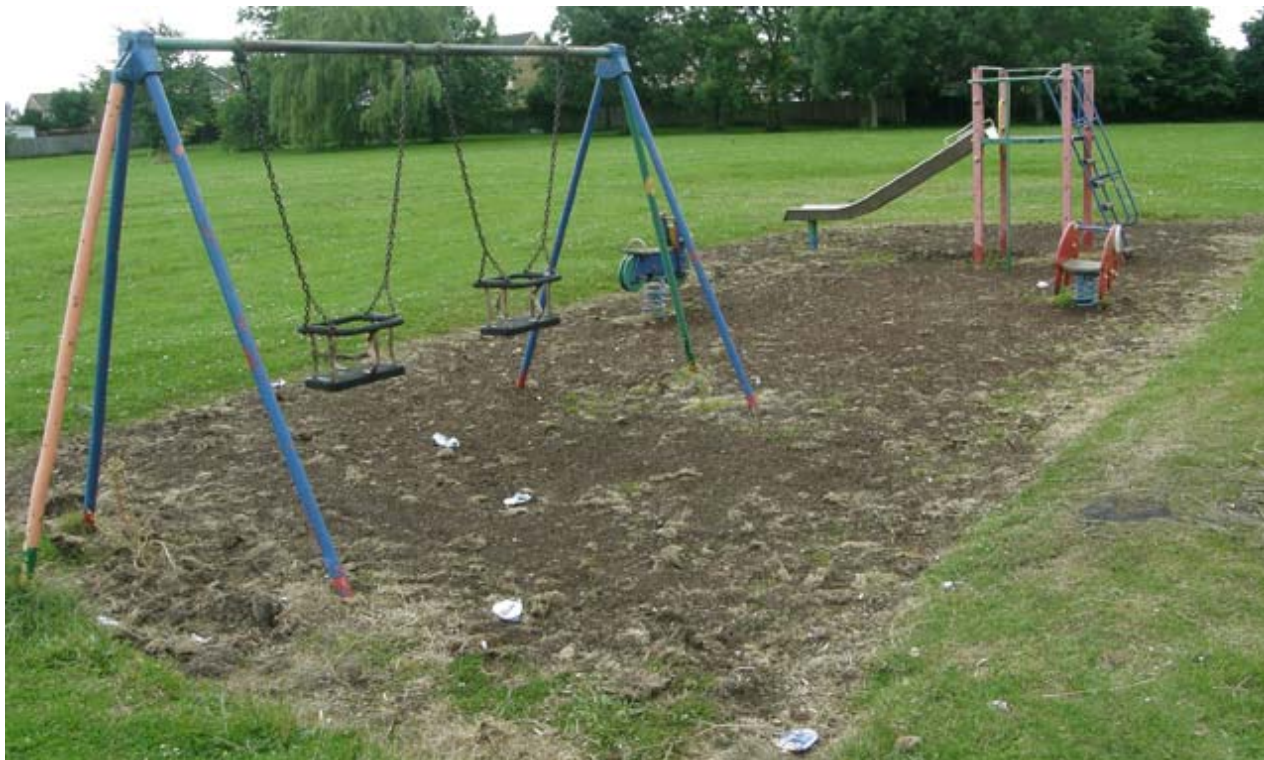
5. Moorville Drive.

Fencing behind equipment in a very bad condition. Land and fencing belongs to the county council, they have been informed about it on numerous occasions.

Legs rotted – seat removed as unsafe for use – Spring 2001. Removed entirely September 2001.

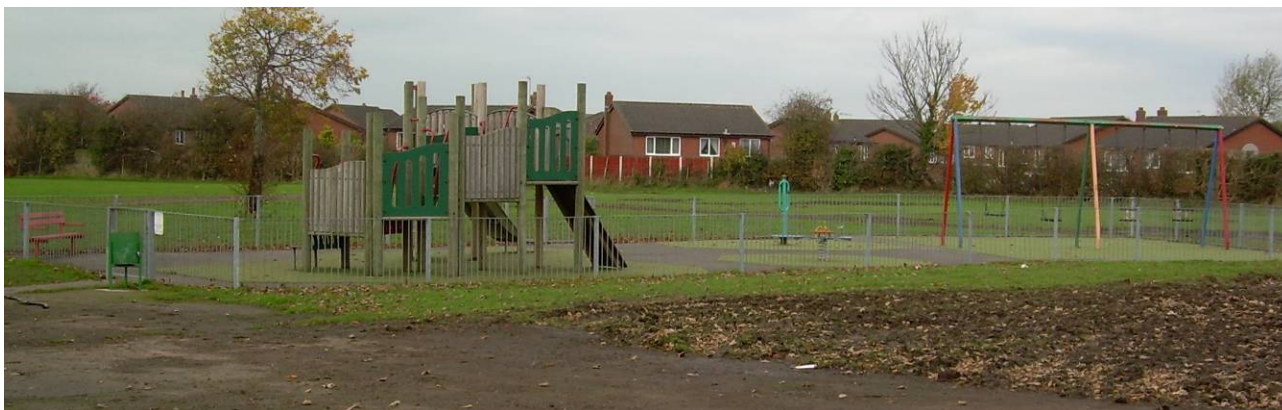
6. Briarbank.

Wet pour surfacing, particularly under spinner frequently vandalised. Spinner removed as no funding to replace surfacing at present, November 2003.

Fire under climber, February 2005. Bridge and adjacent pots burnt. Surfacing ruined in area below bridge.

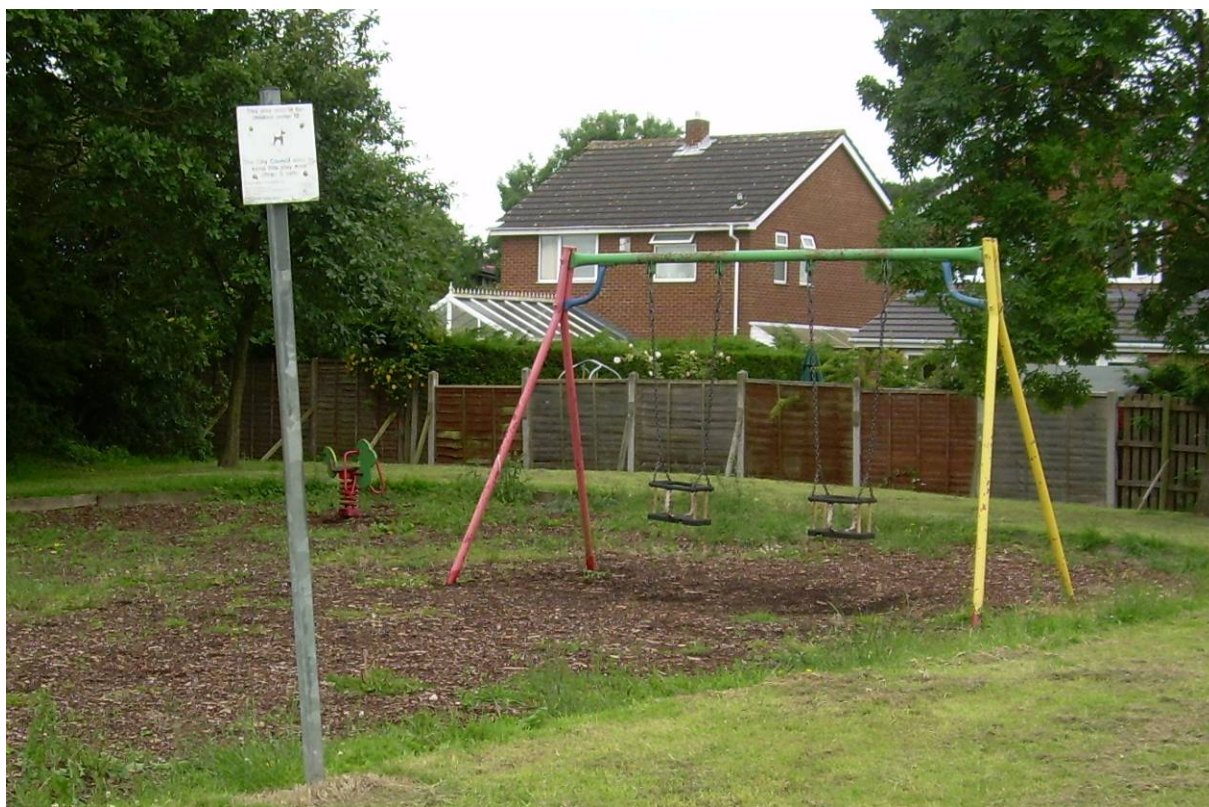
7. Esk Road.

Vandal damage to Cornflower hut throughout summer of '94.

Vandal damage also to Laplanders hut, part of rung broken off. September '94.

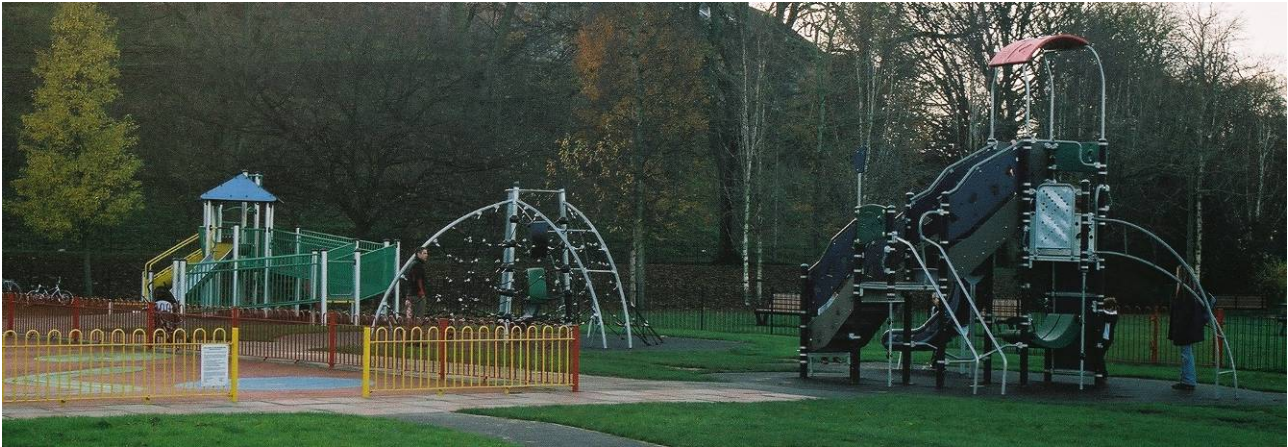
10. Bitts Park

Extensive flood damage, January 2005. Water approximately 8ft high over all play equipment.
 Playground Numbers Survey Aug-Sept 1992
 Used by group of young people with learning difficulties and physical disabilities arriving by coach with carers in early evening. Very well-used.
 Twin bay flat swings reduced to single as it was built over a storm drain. Drain cover raised by United Utilities – this drain is intended to 'blow' when under flood load from the City.

Extensively damaged in flood, January 2004. Cabinet under 8ft of water. Above ground features stored in Bitts Park depot, also under 8ft of water.

Bins vandalised. Not replaced.

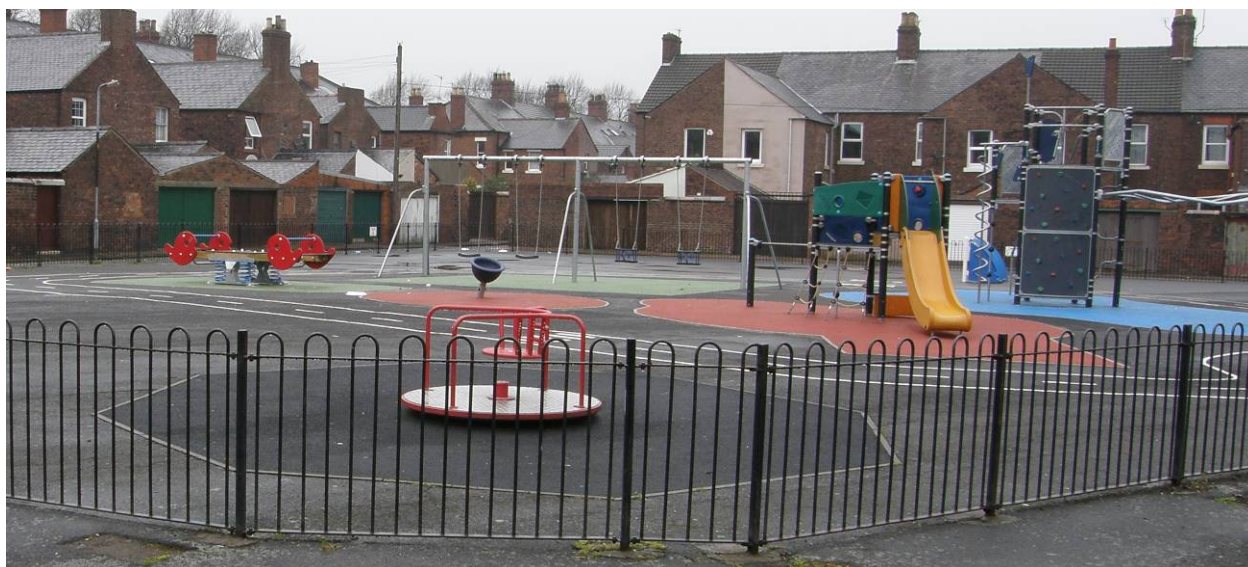
15. **Broad Street**

The land was originally intended as a 'drying area' when the houses were built, the lack of overlooking and 'open-ness' makes the area attractive to ASB.

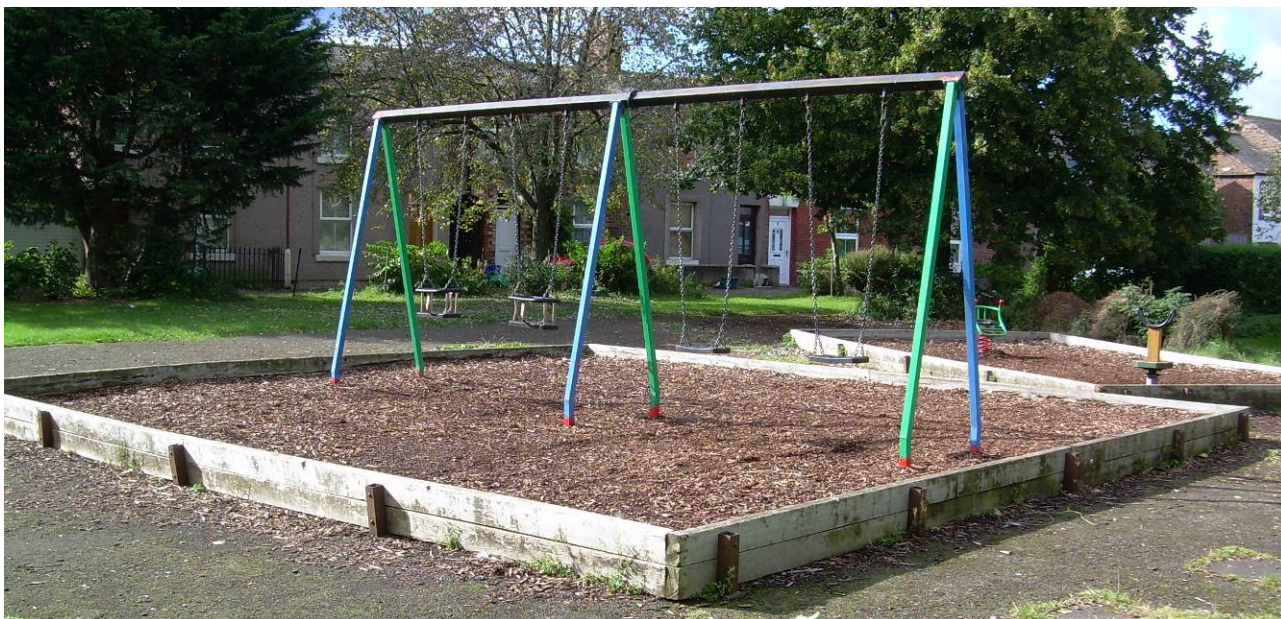
17. *Charlotte Terrace.*

No dog-proof fencing. January '94 - Chain link fencing put up along Charlotte Terrace side at request of residents. Height varies to suit requests of residents in Charlotte Terrace and Victoria Road whose properties front or back onto the playarea. 18/12/97 - in dilapidated and potentially dangerous condition - would recommend taking it out.

Extensive flood damage, January 2005. Seesaw - LTNB Wicksteed, 1969, removed. Bark changed. Playarea cleaned down.

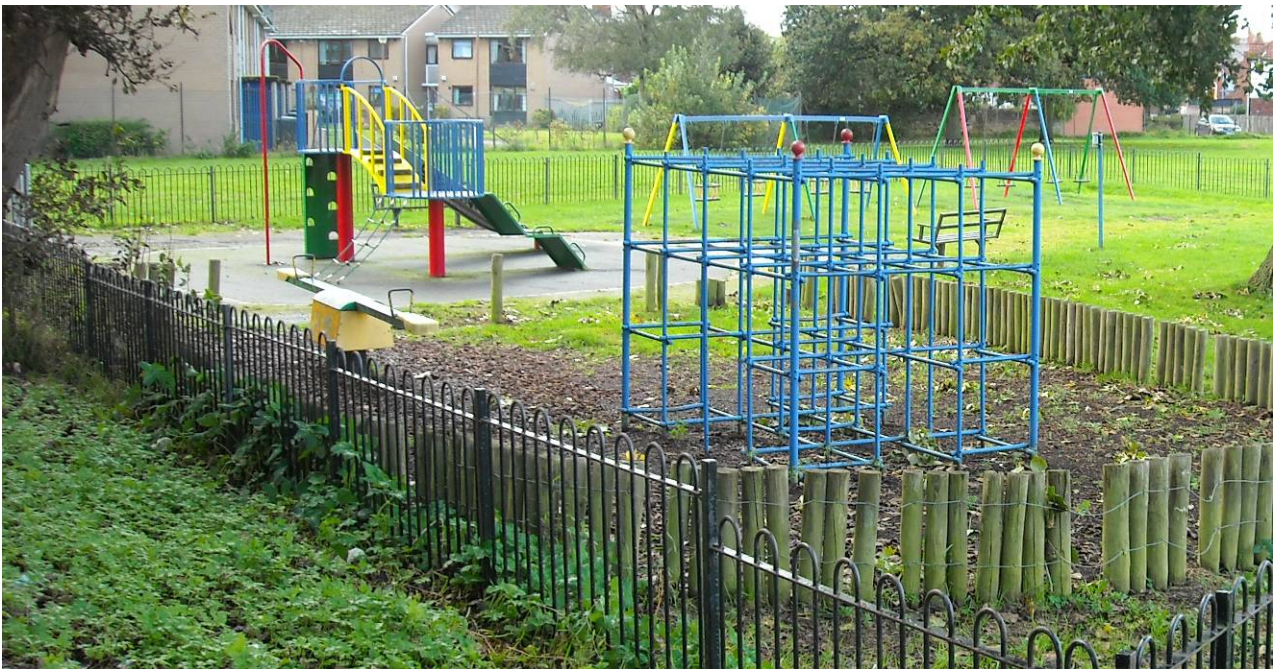
19. Melbourne Park West

Hopscotch marked out in paving but partly hidden under upright log stockade.
Bark topped up 23/1/97
Seesaw - clearance from seat assembly to ground less than 203mm. Does not conform to BS5696 Part2, 10.2.2
Repainted 2008, swings were relocated from Kingfisher Park (Melbourne Park), together with climber.

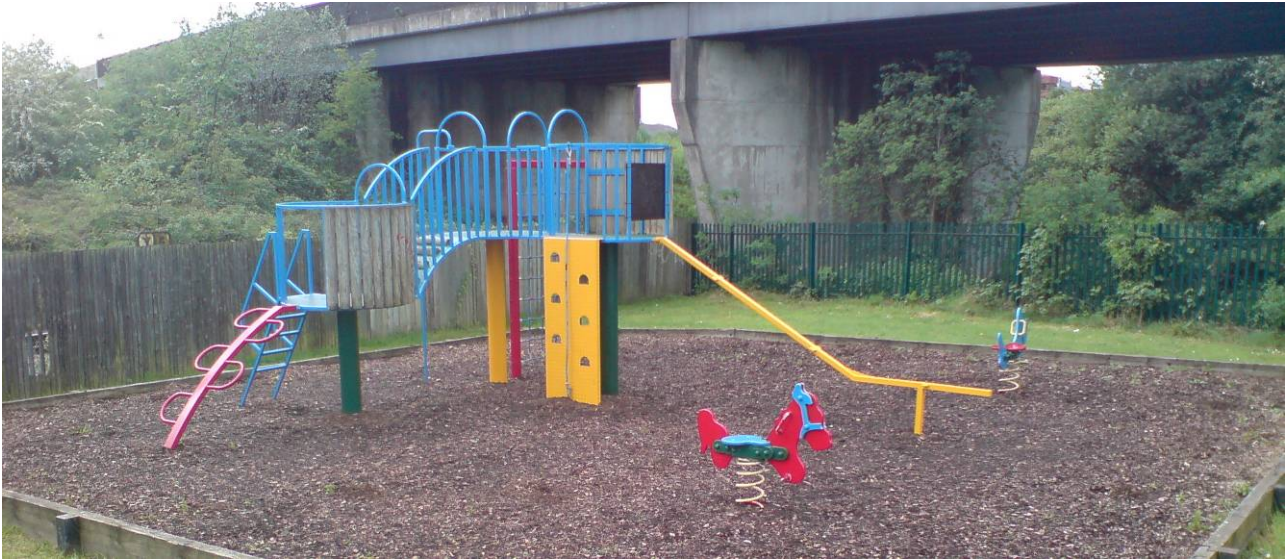
21. *Scotby Gardens*

Yobs constantly tearing it down. Repairs are essential since the railway is on the other side. Needs indestructible metal fence.

Net removed from play unit for repairs, October 1997. Sent to Tayplay. Due for replacement by Parkdale end of 2001.

Stainless steel off the slide was stolen in 2007 – expensive to replace. Site not overlooked, and next to railway.

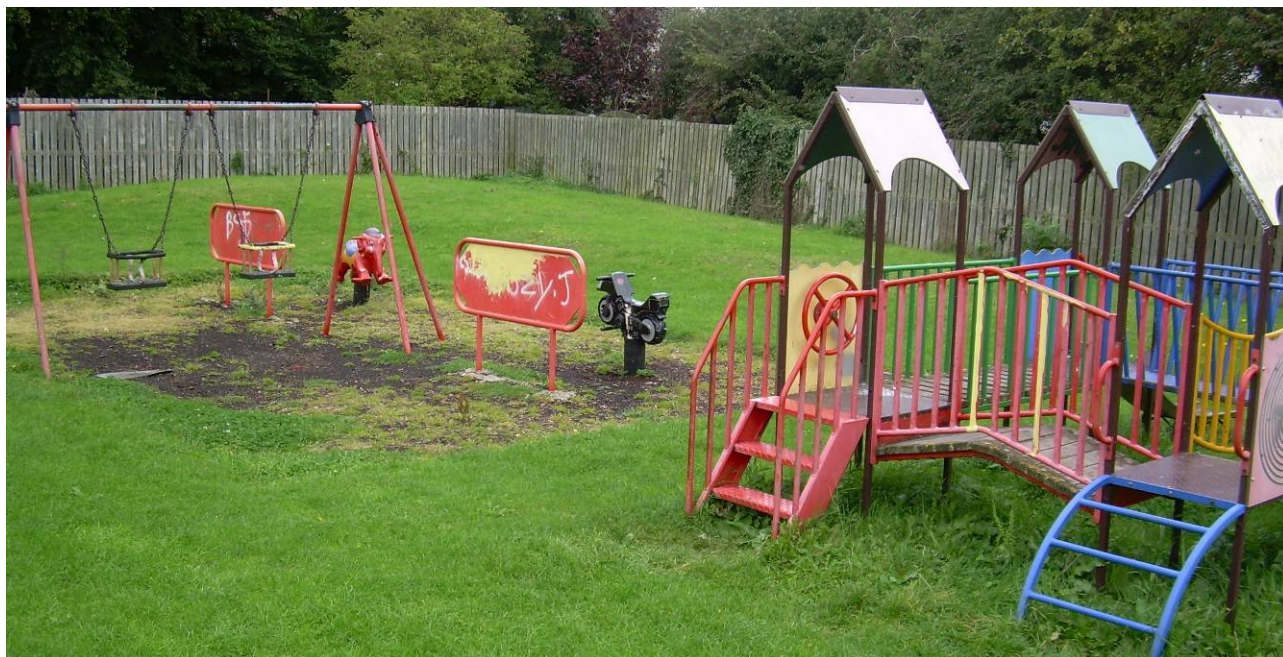
22. Broadoaks Grange

Close board fencing 1.8m high on posts and rails round entire site. Stretch next to Durranhill Road vandalised and replaced with 1.8m high round top, green painted, palisade security fencing – December 2003

Crawl tunnel vandalised and replaced with a bridge as top of tunnel too high to conform with EN regulations on no surfacing – November 2000.

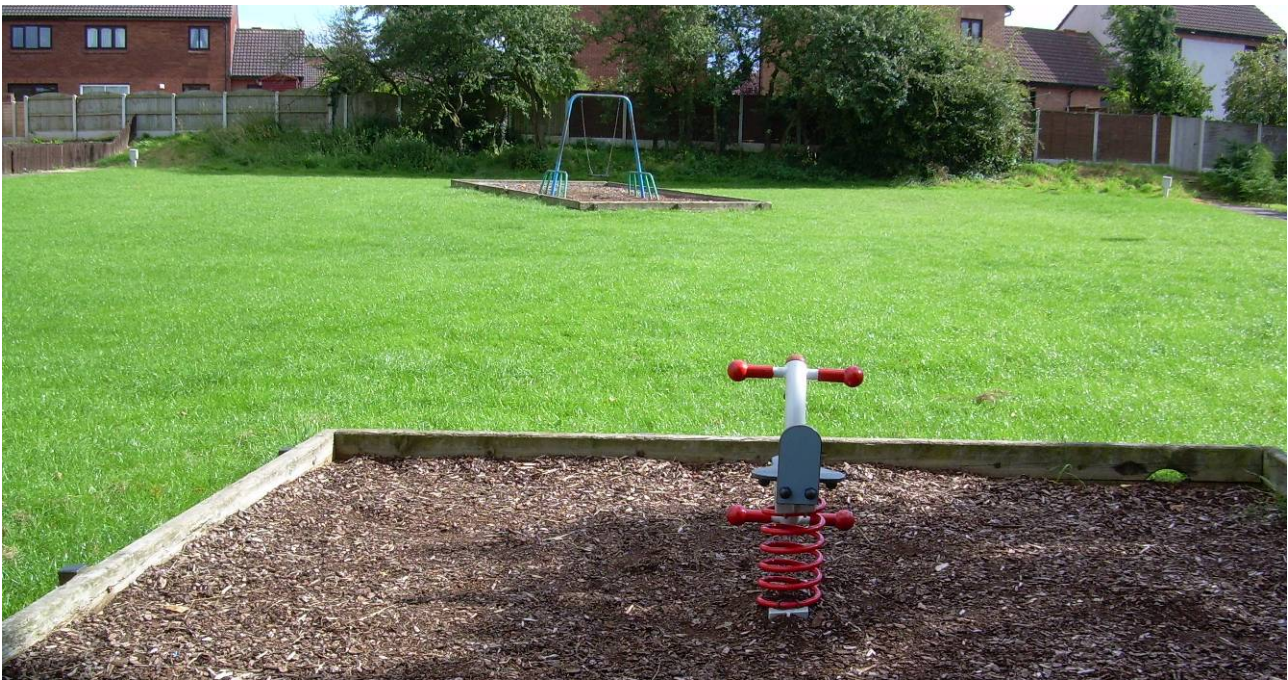
25. *Lonsdale Grange*

September '98 Screws keep dropping out of lower part of rotating corkscrew crossing corkscrews. (3 flat-headed alan screws). Replacement part no. 2171 159. M6/30 socket countersunk screw. Replacements bought. Wicksteed came to sort it out eventually as these screws did not fit.

Roundabout – Area insufficient 5.9m x 5.9m Should be 6.4m x 6.4m (noted in post-installation report) Has red rim round the edge of the surfacing.

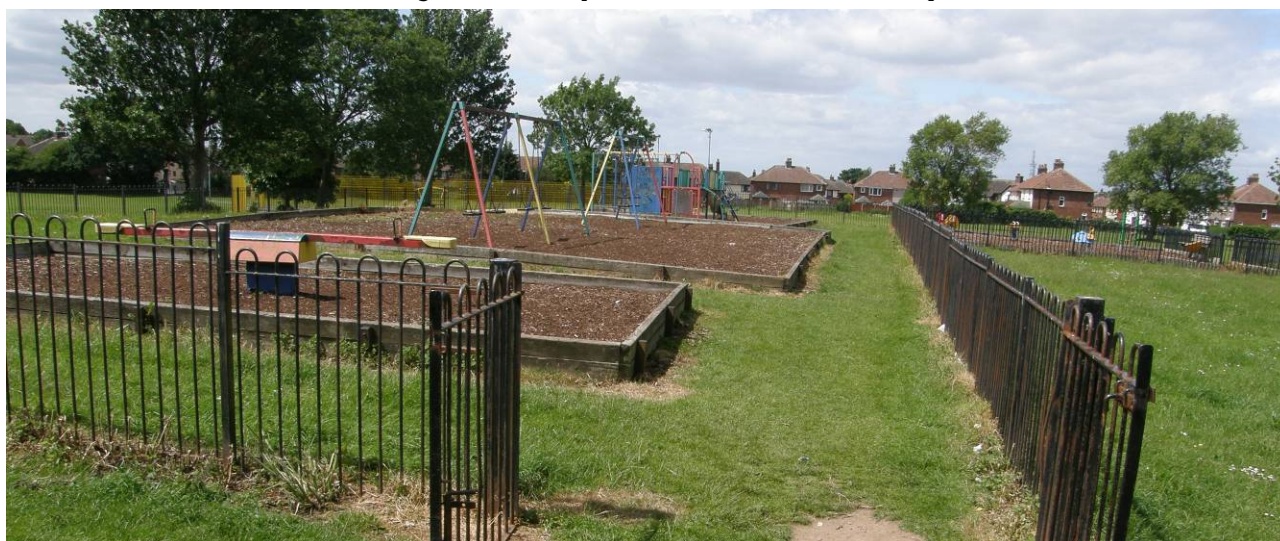
29. *Petteril Valley Park (Dale End Road).*

Swings - 2.4m, one bay two seat, cradles	Record Swingmaster	1997
Swings - 2.4m, two bay, four seat, flats	Record Swingmaster	1997
Seesaw - LTNB	Wicksteed	
Multi-play unit - Adventurer	Record	1993
Slide on above does not meet BS

Record unit burned before bonfire night November 1993. Floor decks a write-off. Replaced.

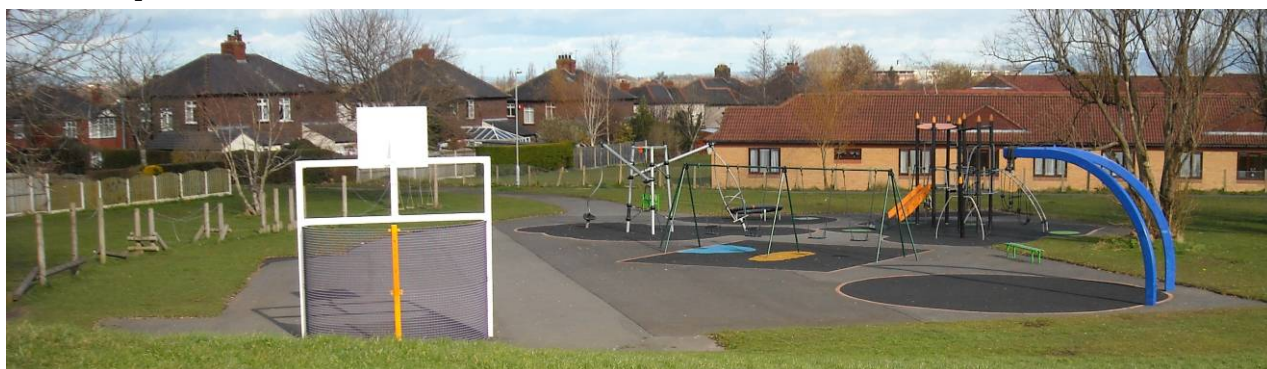
45. Spider Park.

Re-furbished in 2007. Shortly after installation, wet pour slumped – clearly as a result of innadequate compaction prior to wet pour installation. New drains installed in 2007 (area was under water after refurbishment).

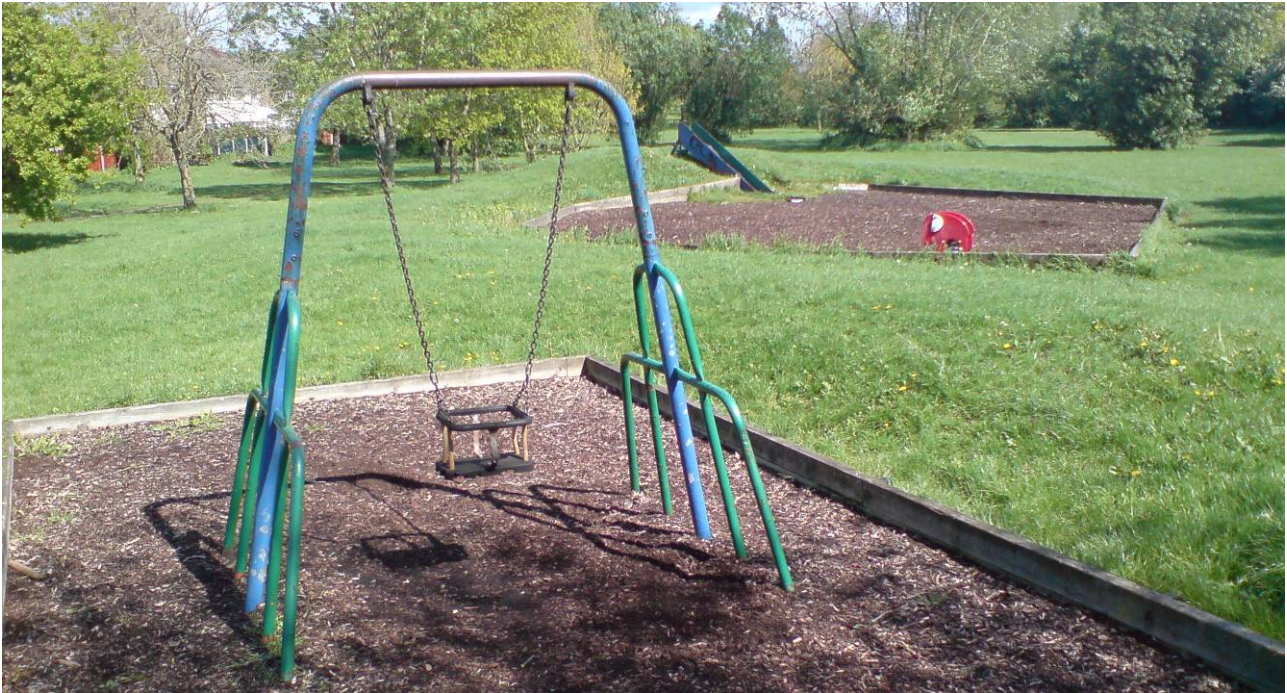
48. Heysham Park (Green Lane).

Swing - 8ft, single arch, flat seat
Spring item - Nellie
Embankment slide
Slide does not meet BS requirements
