Carlisle City Council

Title: DEPUTATION FROM FRIENDS OF CARLISLE VICTORIA AND TURKISH BATHS
Report of: DEPUTY CHIEF EXECUTIVE
Report Number: CS 19/22

The purpose of this report is to provide members of the City Council with relevant background information concerning the operation and future development of the Turkish Baths at James Street, Carlisle.

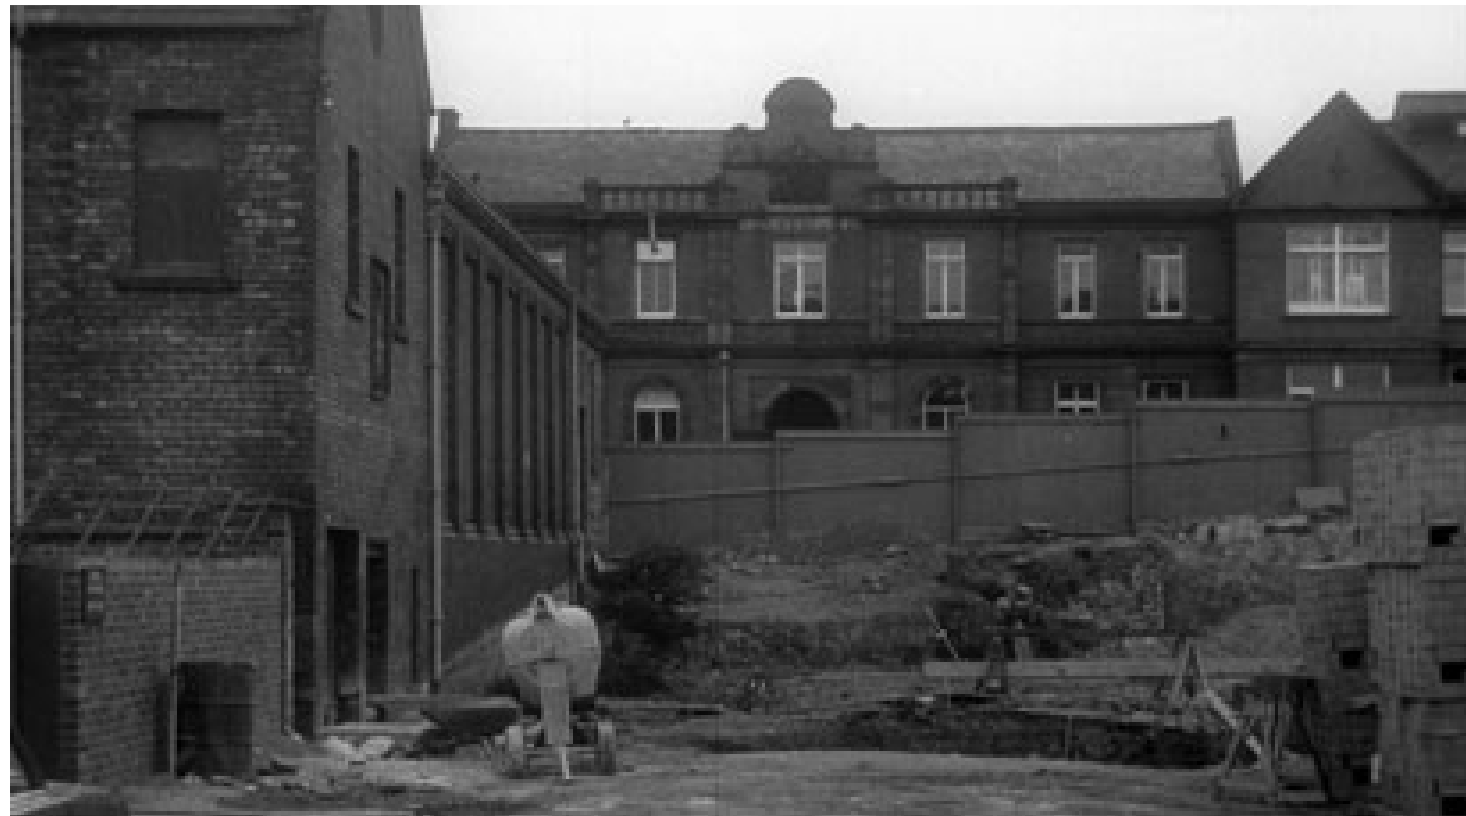
Figure 7: West elevation visible and foundations of the new Carlisle public baths, c.1974.
Source: Cumbria Image Bank. ref: ct09040

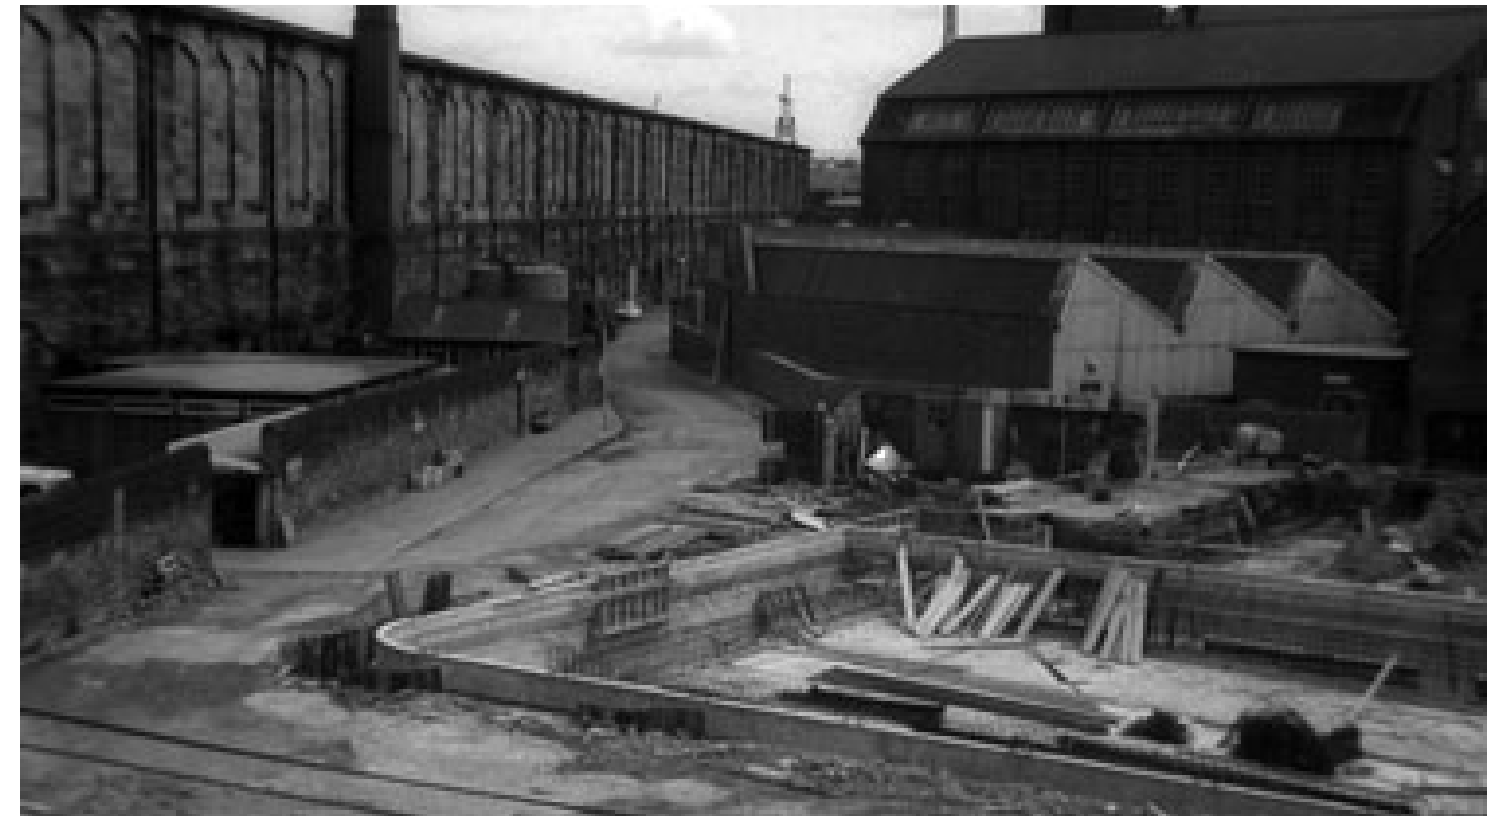
Figure 8: Foundations of the new Carlisle public baths, c.1974.
Source: Cumbria Image Bank. ref: ct08301

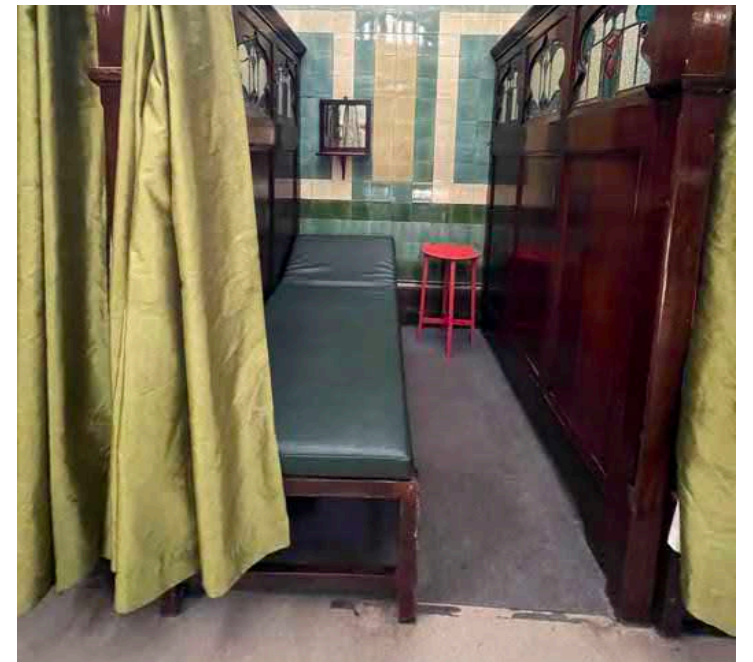
Image 12

Existing changing booths with poor quality and degrading floor finishes.

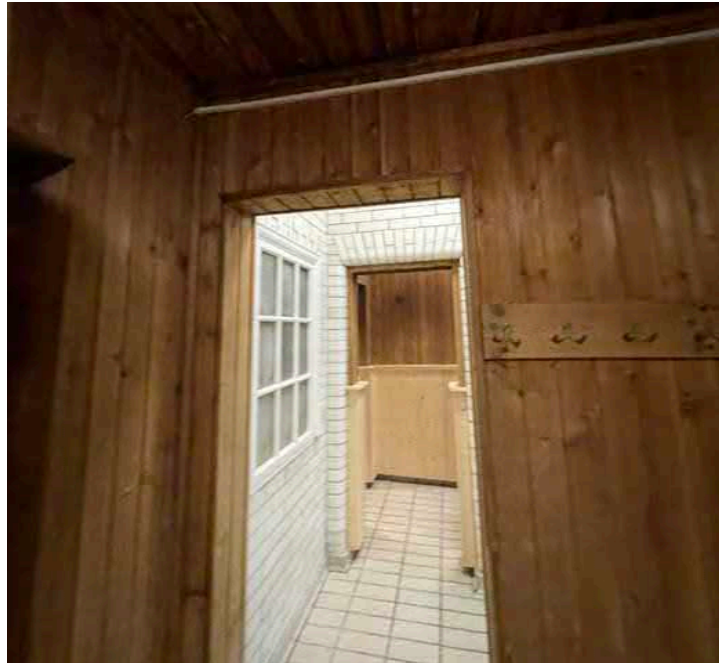
Image 13

Areas of existing glazed tiling. Sauna/ hot room areas lined within poor quality and degrading timber.

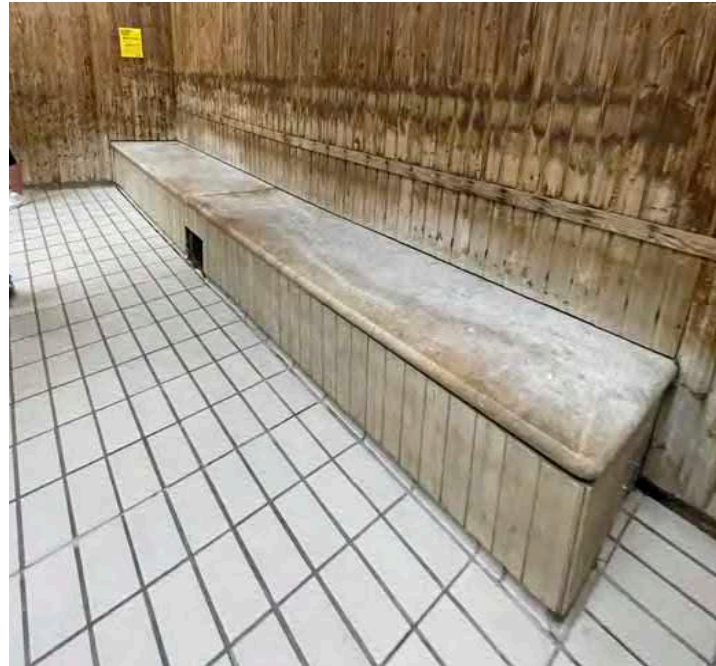
Image 14

Marble topped sauna bench. Low quality and degrading wall linings and floor tiling.

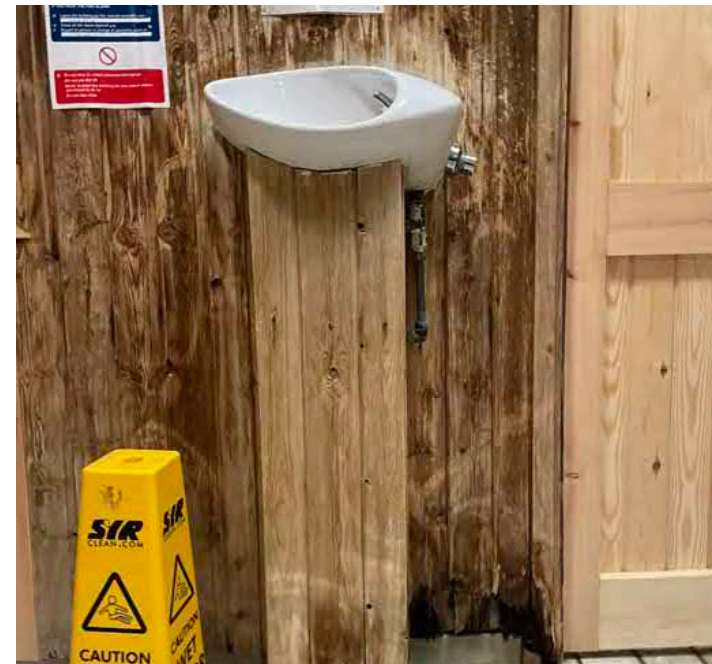
Image 19

Sauna room, low quality fit-out materials showing signs of age and decay.

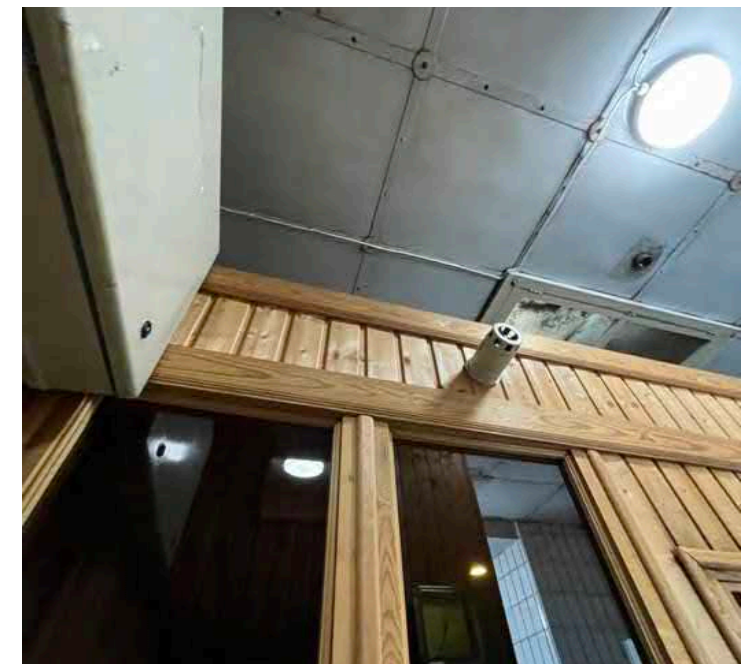
Image 20

In-laid metal ceiling hosting large light fittings not inkeeping with the building.

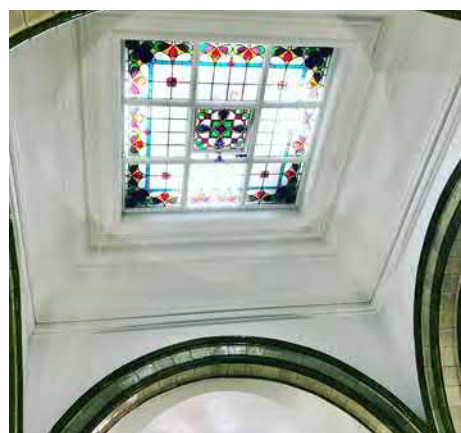
Stained glass roof light.

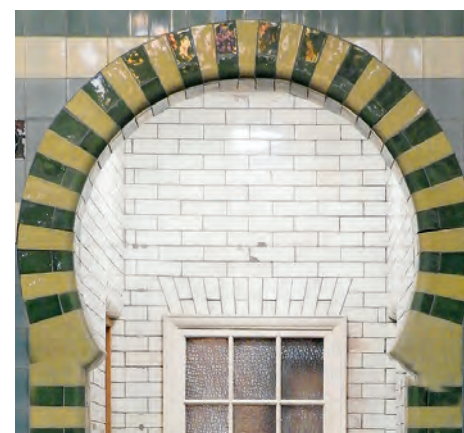
Glazed tiling.

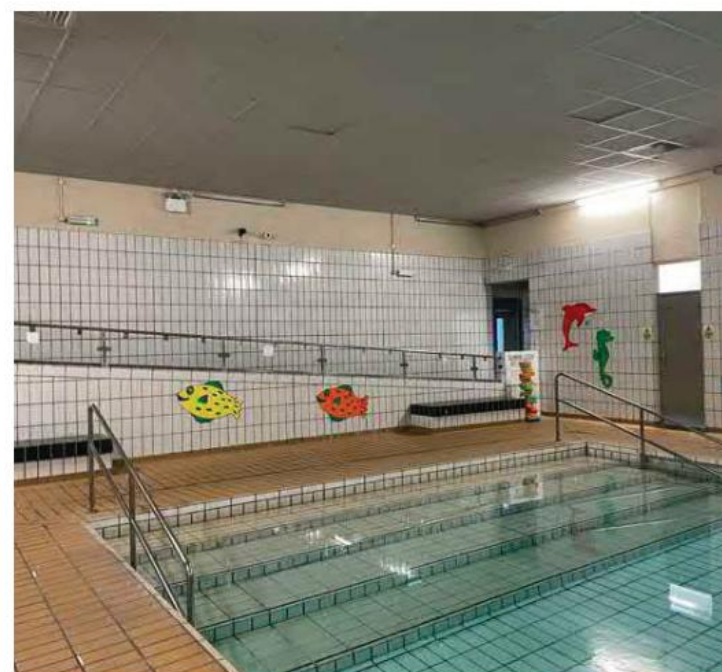
Suspended grid in-lay ceiling above the small (10m) pool showing signs of wear and deterioration

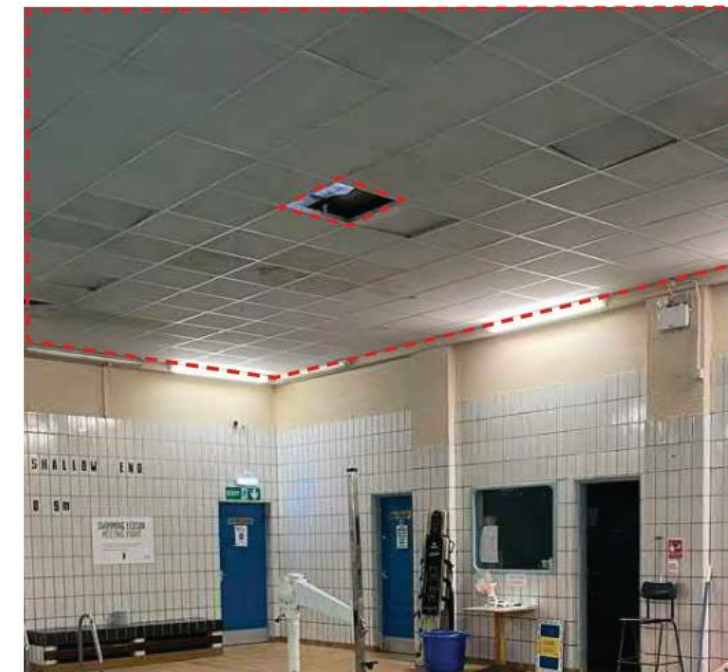
Suspended grid in-lay ceiling above the large/main pool ceiling tiles missing or damage/ lifting

Removing the suspended lay-in grid ceilings from over the main swimming pool will immediately change the experience and usability of the halls. It is not known what condition the soffit of the existing pitched roof or roof lights are in, however the building appears to be weather-tight, with limited staining on the visible face of the existing ceiling. At roof level the glazed roof lights appear to have had relatively recent refurbishment works.

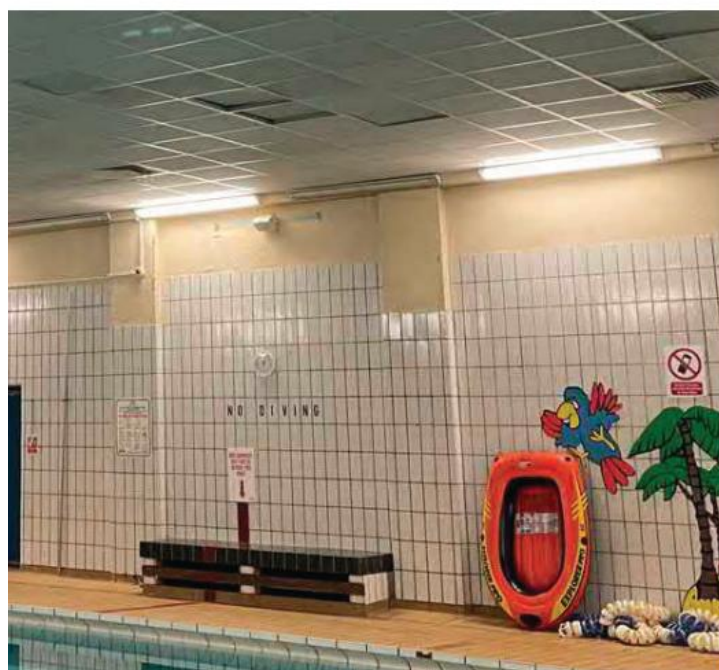
4. Wall hung lighting to be replaced.

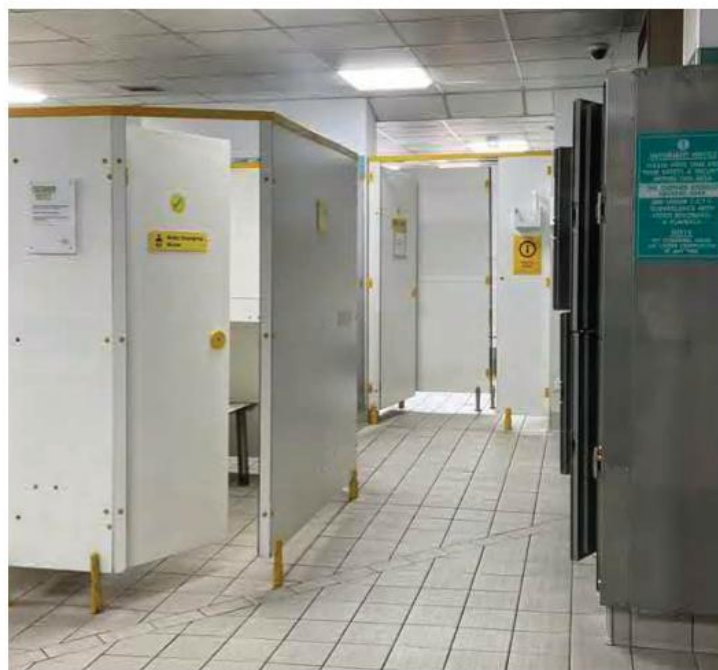
5. Changing room fixtures to be removed.

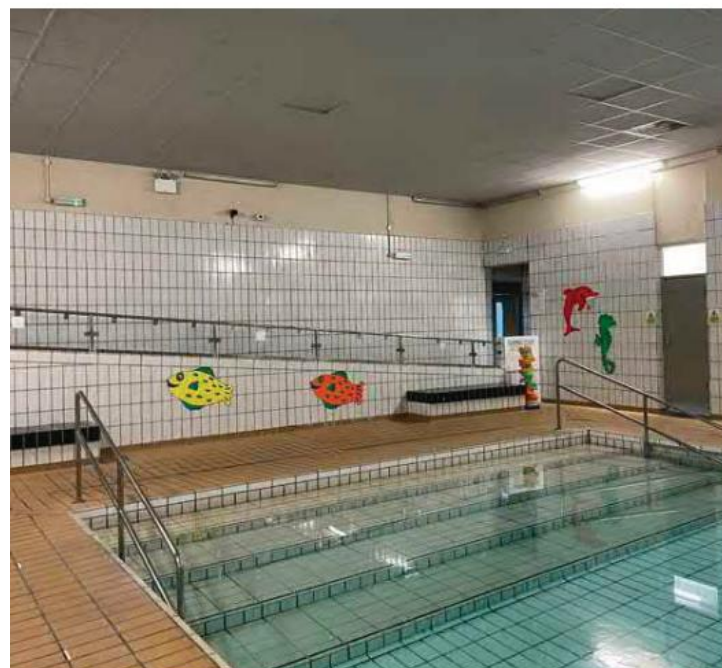
Proposed fire retardant timber floor
lining to level out pool floor surfaces.

As the pool halls have sloping tiled pool surrounds to provide drainage to the wet-areas around the swimming pools, these should be levelled off with a continuous surface finish across the decked pools. Marginally raising the floor level of the pool halls in this manner could be accessed through local ramping at required door thresholds. Tiles and drains should remain in situ. It is proposed that a timber batten system could adequately raise the floor level, to be coordinated with the proposed steel-deck system to board over the main pool tank. All proposals are indicative and subject to further development and detailed design.

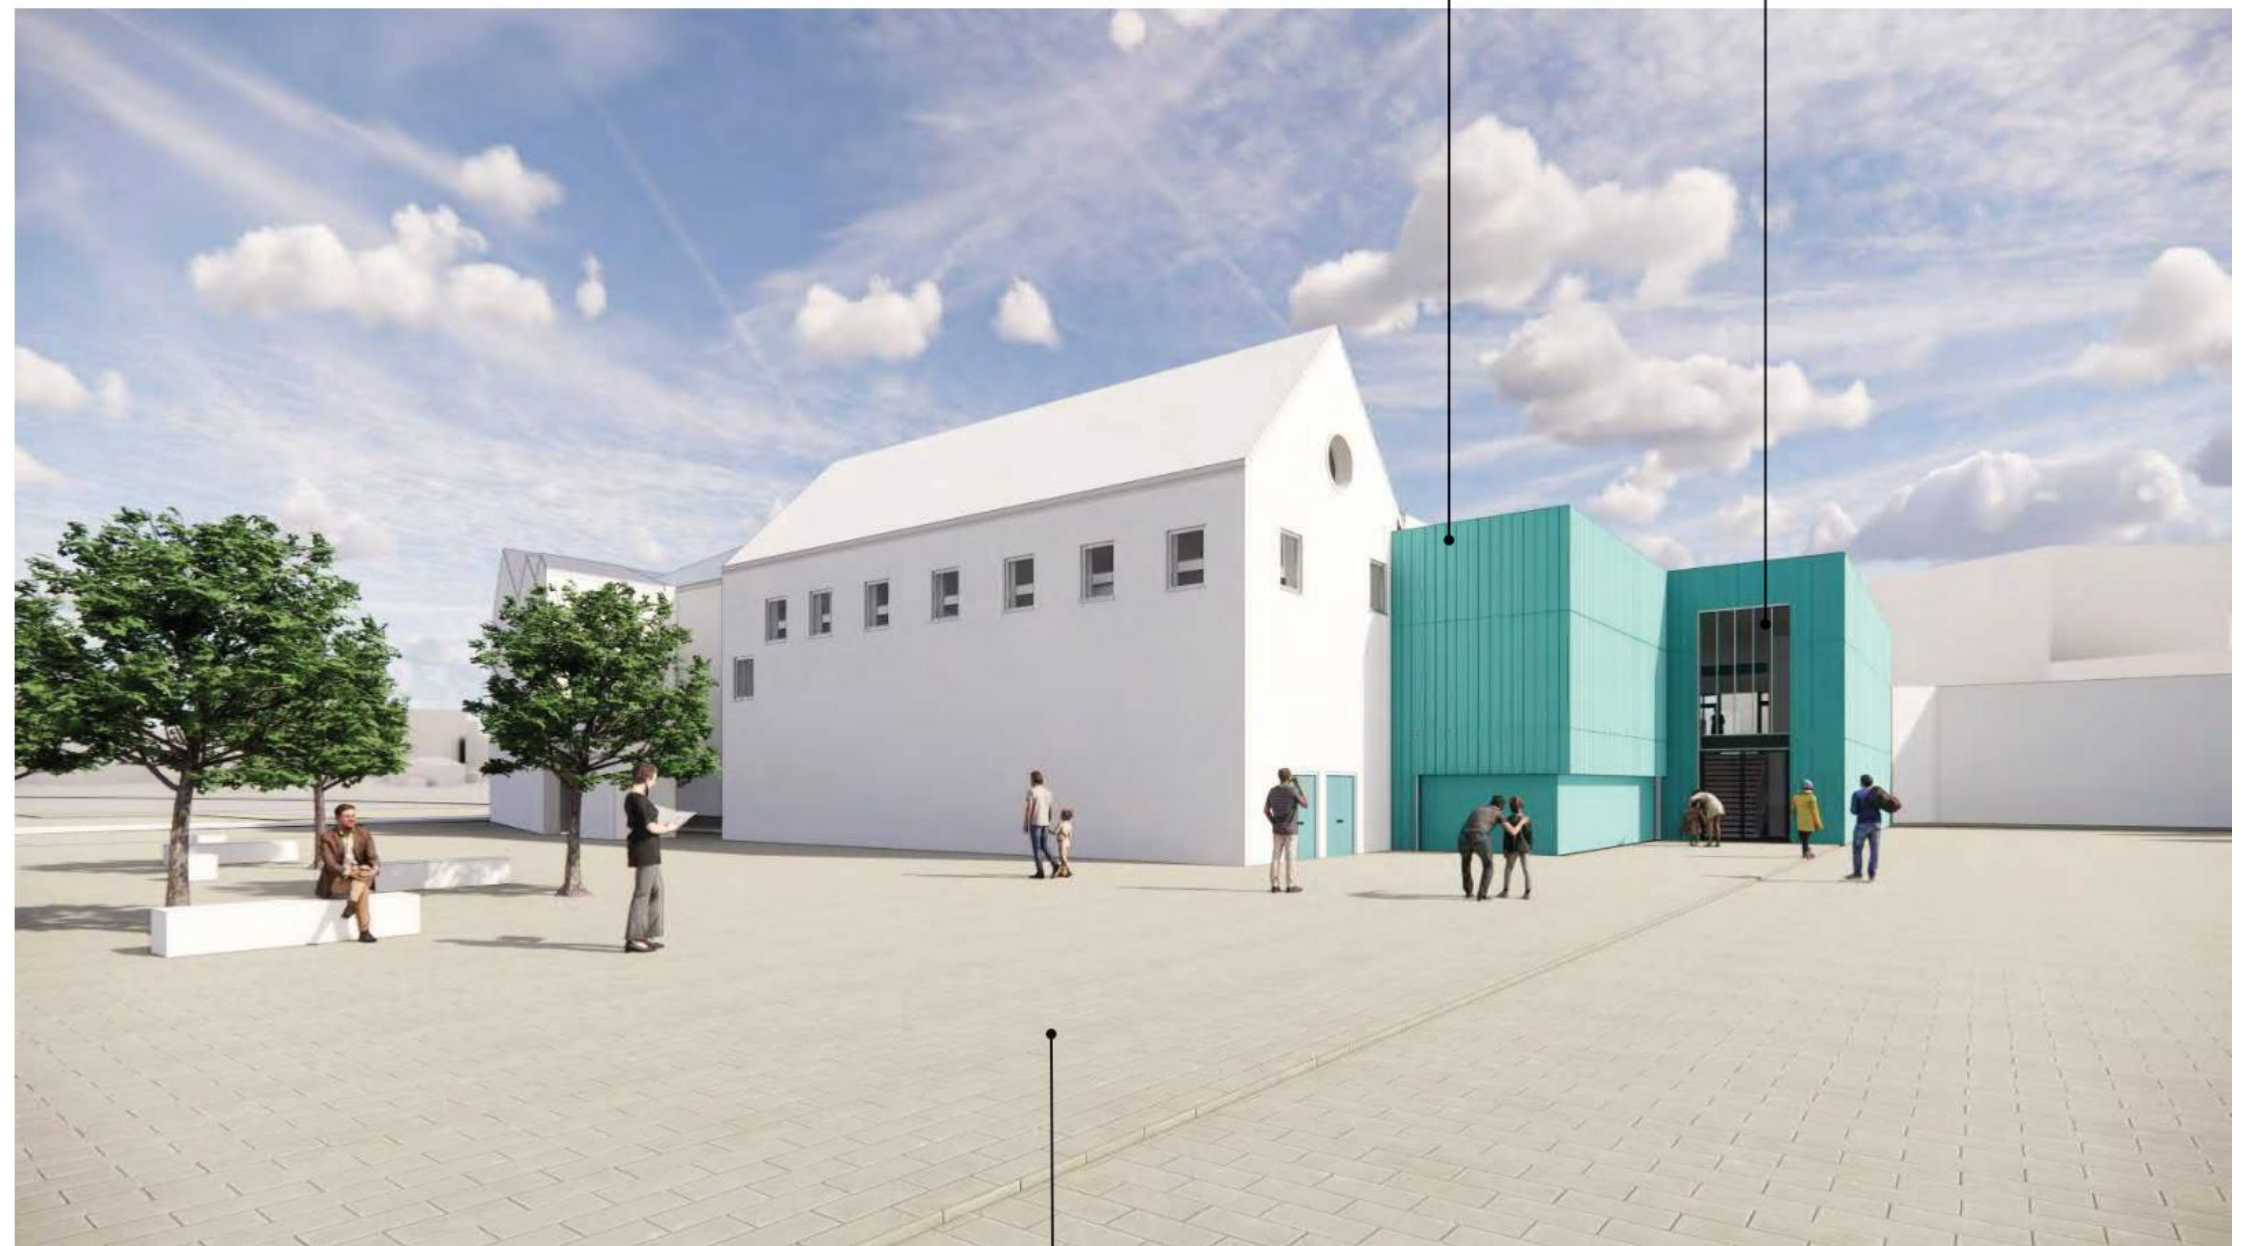
Figure 72: Indicative image of proposed reuse of the small pool hall.

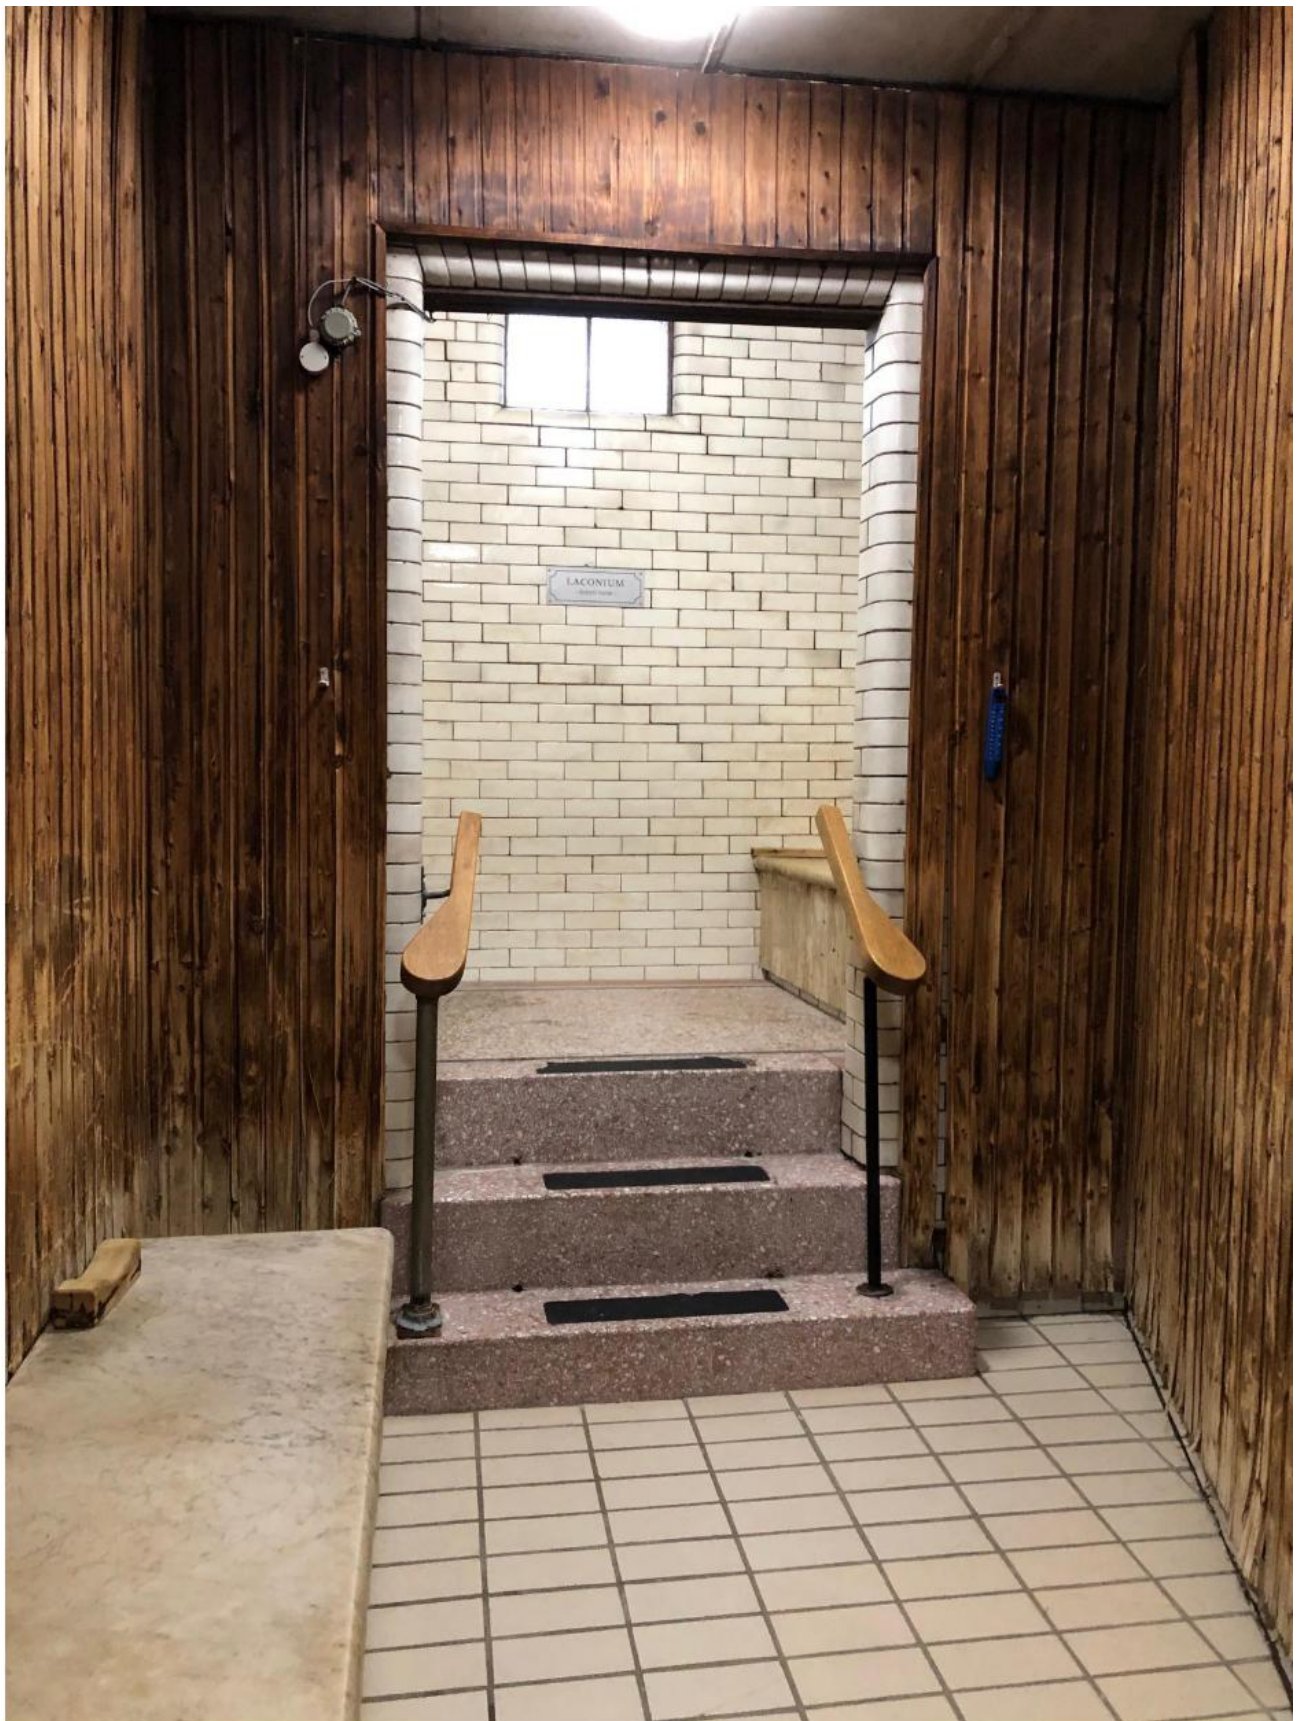
Fig.42: Interior showing hot rooms no. 2 and no. 3 (dated 2019 before the timber t&g was replaced)
